USAARL Report No. 2003-08

The Role of the Pilots Night Vision System (PNVS) and Integrated Helmet and Display Sighting System (IHADSS) in AH-64 Apache Accidents

U.S. Army
Aeromedical Research
Laboratory

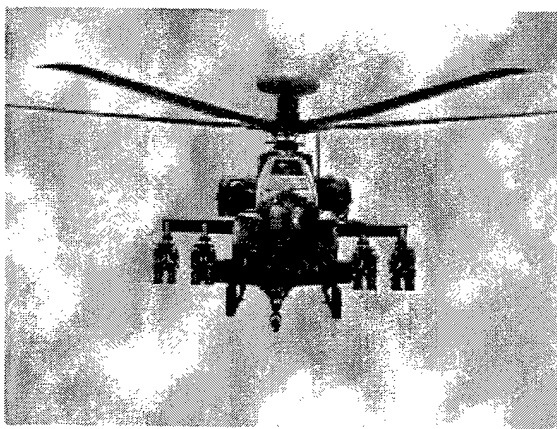
Figure 1. The AH-64D Apache helicopter.

The AH-64 Apache is the U.S. Army's most advanced rotary-wing attack aircraft (Figure 1). It exists in two model configurations, the AH-64A and AH-64D. The AH-64D is referred to as having a "glass cockpit." This reference is made to the modified crewstation design employed in the AH-64D that replaces most of the traditional dedicated instruments with multifunction displays (MFDs). The D-model also has an expanded mission capability and may present a higher workload cockpit.

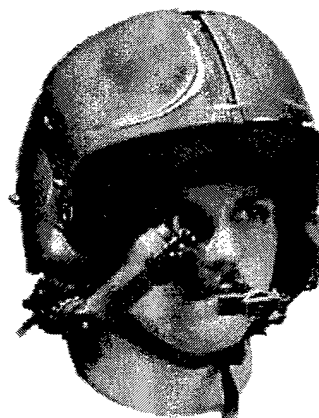
Figure 2. The Integrated Helmet and Display Sighting System (IHADSS).

The AH-64 is flown using a helmet-mounted display (HMD) known as the Integrated Helmet and Display Sighting System (IHADSS) (Figure 2). This HMD presents pilotage imagery and flight symbology. Pilotage imagery originates from a nose-mounted forward-looking infrared (FLIR) sensor known as the Pilot's Night Vision System (PNVS). Several studies (Behar et al., 1990; Hale and Piccione, 1990; Crowley, 1991; Stewart, 1997; and Rash et al., 2002) have identified a number of visual problems and illusions that may be contributing factors to AH-64 accidents.
